CASE STUDY HOUSEHOLD PLASTIC PAINT CONTAINER RECYCLING TRIAL

HOUSEHOLD RECYCLED PLASTIC PAINT CONTAINER CLOSED LOOP TRIAL LIFE CYCLE

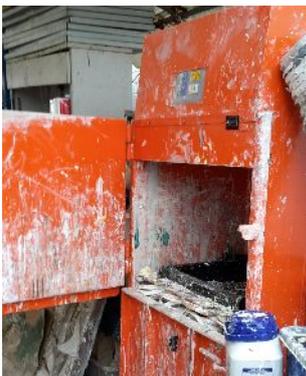
Figure 1;
Baler at
CCORRN

At CCORRN the paint was decanted and the containers prepared and stored. Any metal handles were removed prior to baling by a single shift baler (below).

The bales produced were unstable due to lack of pressure and the pressure being vertical. Each bale took on average 30 minutes labour time to prepare and on average weighed 29 kilos. Stacking of the bales was not possible due to their instability.

The bales were stored outside. Modifications to the baler resulted in the bales being more compact and heavier. The labour time to prepare each bale was an average of 30 minutes per bale.

- Vertical balers are not suitable for the task. The trial indicates that from an operational view point shredding at the hub would reduce labour, allow for increased levels of storage and transportation.

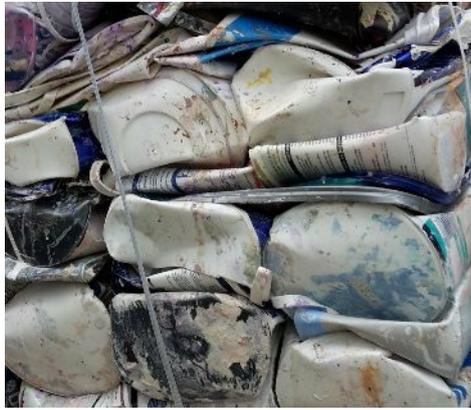
Figure 2; Baled plastic paint containers

The bales had to be covered prior to transportation due to exterior contamination and were bagged in clear plastic pallet bags for shipment.

44 of the prepared bales were collected for reprocessing, the total weight of material was 1440 Kgs.

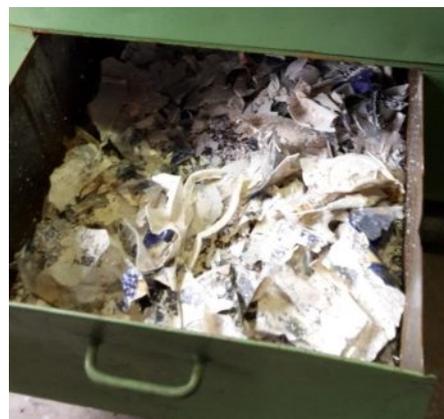
Figure 3; Plastic paint containers put through granulator used as a shredder.

Alternatives were researched for the baler. Using a granulator as a shredder proved to be a quicker preparation process and allowed for easy storage and bagging prior to shipping.

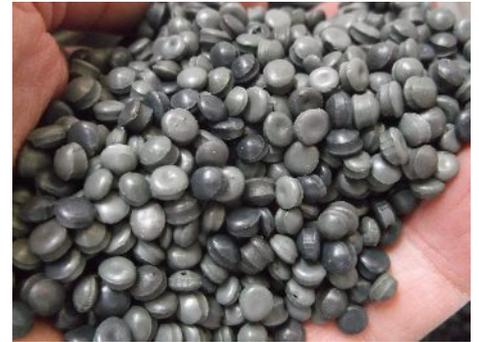
Figure 4; Pellet from recycled plastic paint

The bales were shredded, washed and processed into pellet. From the 1440 Kgs of baled material, 619 Kgs of pellet was sent to RPC for moulding. The contamination was mainly dry paint residue on the inside and outside of the containers.

The pellet, which was 100% recycled plastic paint containers was stiffer than that normally used by RPC. The trial was conducted using 100% of the reprocessed recycled plastic paint container pellet to mould containers.

- 1 440 Kgs of baled material delivered for reprocessing.
- Recovered compound pellet 619 Kgs (43%).
- 5% yield loss.
- Contamination 749 Kgs, (52%).

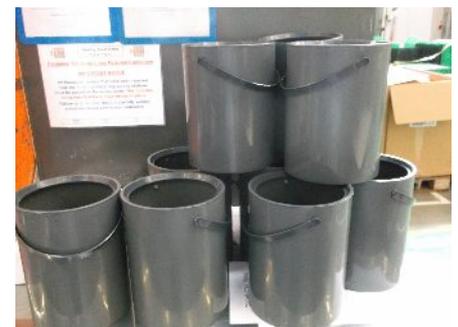
Figure 5; Moulded plastic paint container from recycled plastic paint containers

Although the material moulded successfully the containers did not pass the stringent quality control at RPC.

Further laboratory tests indicated that the low melt flow rate of the material was likely to be the main reason for the failure. The laboratory tests also showed that there was a 3-5% of PE material within the compound pellet. It is not known if the pellet could be incorporated at a reduced percentage with other recycle or virgin material to complete the closed loop process.

- While the trial has indicated that the material could be recycled, further work would need to be undertaken to understand why the Melt Flow Rate was so low. Solving the MFI issue would be necessary to recycle post-consumer paint containers into new paint containers.

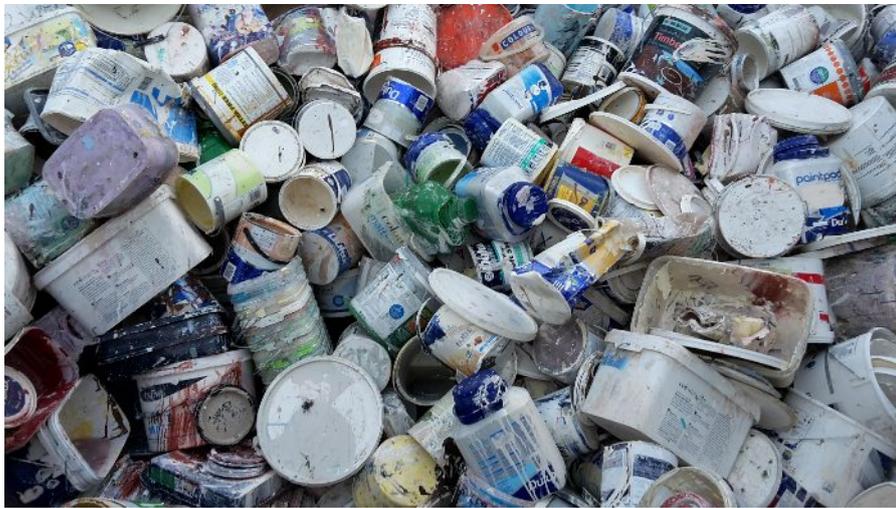
Figure 6; Post-consumer plastic paint containers prior to baling at CCORRN

Full and part-full containers were collected from 6 HWRCs in Cambridgeshire and 3 HWRCs in East London, via Community RePaint. The containers were taken to the Community RePaint Scheme in March, Cambridgeshire (CCORRN), managed by Resource Futures.
